Manhole Inspection Summary

Manhole # S43I2_003MH

Insp Date: **1/9/08 8:13 AM**

Location Address: **Church St**

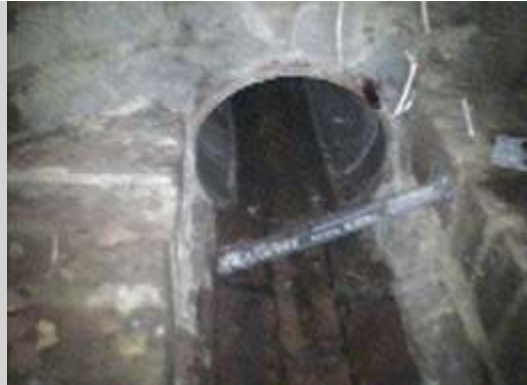
12 O'Clock Outflow

8 in. Circular Gravity Sewer
Pipe Out @ 12 O'Clock

Pipe Height: **10.8** (in.) Rod and Bar (Angled)
Pipe Material: **Clay** ☐ Pipe Lined
Invert Depth: **10.78** (ft.) Flow Characteristics: **Fast**
Deposits: ☒ None ☐ Mud ☐ Sludge ☐ Debris ☐ Grease
Silt Depth: (in.) Deposits Extent:
Infiltration: **None** Pipe Seal Cond: **Sound**

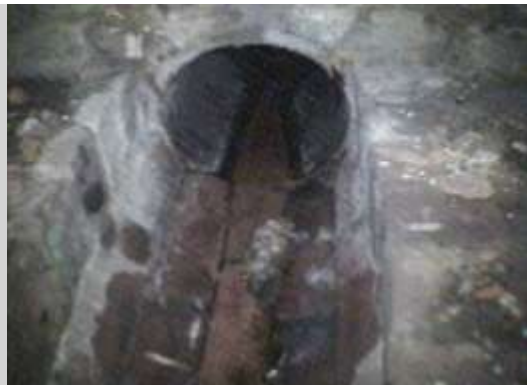
6 O'Clock Inflow

6 in. Circular Service Sewer
Pipe In @ 6 O'Clock

Pipe Height: **9.6** (in.) Rod and Bar (Angled)
Pipe Material: **Clay** ☐ Pipe Lined
Invert Depth: **10.57** (ft.) Flow Characteristics: **Fast**
Deposits: ☒ None ☐ Mud ☐ Sludge ☐ Debris ☐ Grease
Silt Depth: (in.) Deposits Extent:
Infiltration: **None** Pipe Seal Cond: **Sound**
